# Inspecting, Cleaning, or Replacement of the Front Power Bus

*1976 XJ-S*

*September 25, 2005*

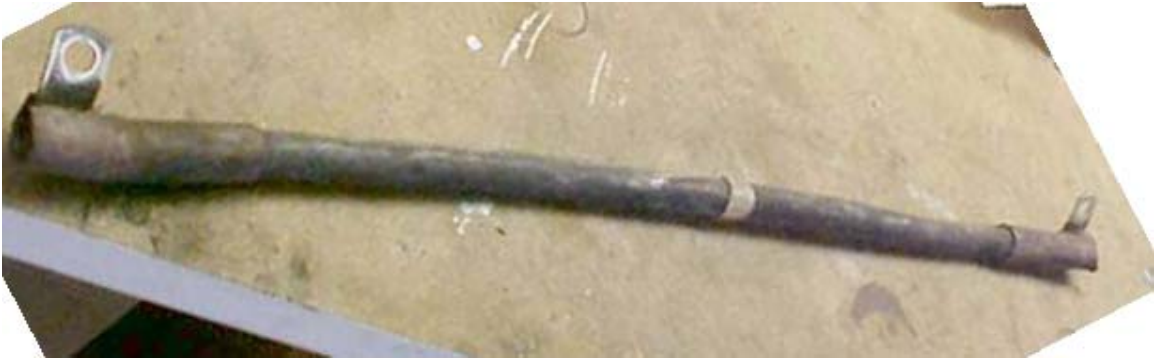
**Figure 4 Front power bus**

There are actually three nuts on each post. The outer one holds the cables that are tapping power off the post, while the inner one fastens the bus to the post. Once the latter has been removed on both sides the bus can be freed from the posts and maneuvered out of the trough in which it rests against the firewall. It is shown on my workbench in Figure 4, before cleanup.

The third nut, the one that you can see in the photos, holds the terminal post to the firewall. *Do not remove or loosen this nut.*

I scrubbed the entire cable with a spray-on electronics solvent and brushed with a soft wire brush. I was surprised to see that it was really in very good shape, as can be seen in a close-up of one end, Figure 5. I also used a digital volt-ohm meter to measure the resistance from end to end; it was as close to zero as my meter could measure
