Inspecting, Cleaning, or Replacement of the Front Power Buss

Edward F. Sowell
1976 XJ-S

September 25, 2005

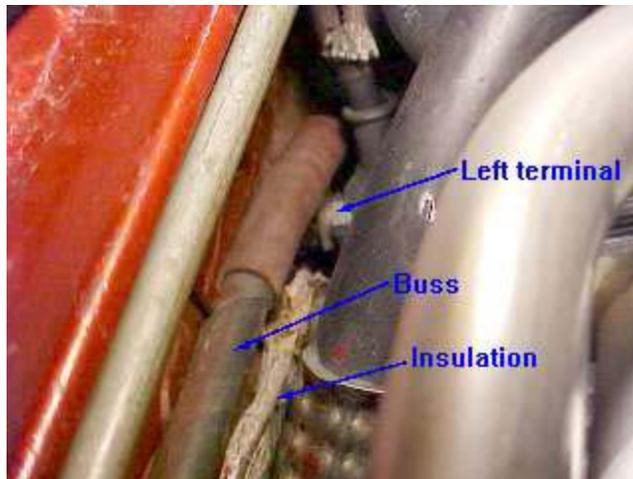
The buss is in a rather difficult place to get at, running along the top of the firewall in a trough formed by a molded fiberboard insulation panel. Figure 1 shows it in place where it attaches to the left terminal post. This photo was taken, from the right side of the car, after the cleanup job. Before it was cleaned it was hard to even know it was there amongst the jumble of other pipes, hoses and wires in the area.

Figure 1 Front Buss on firewall, left end

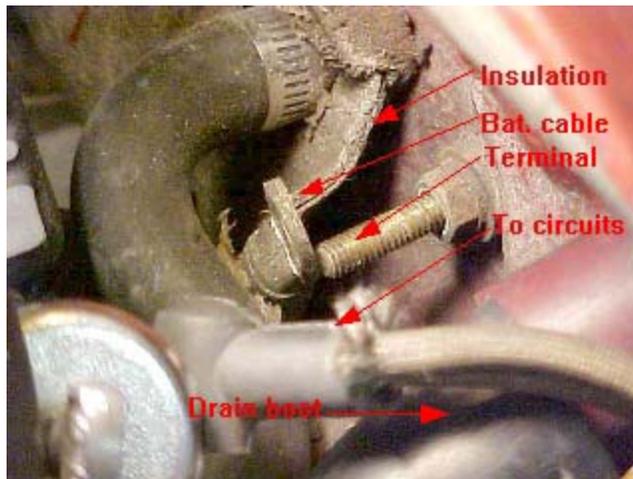
Figure 2 shows the left post after the buss has been removed.

Figure 2 Left terminal post

Another problem, at least on my car, is the molded fiberboard insulation panel on the firewall. I had to whittle it away a bit to get the cables off the terminal post.

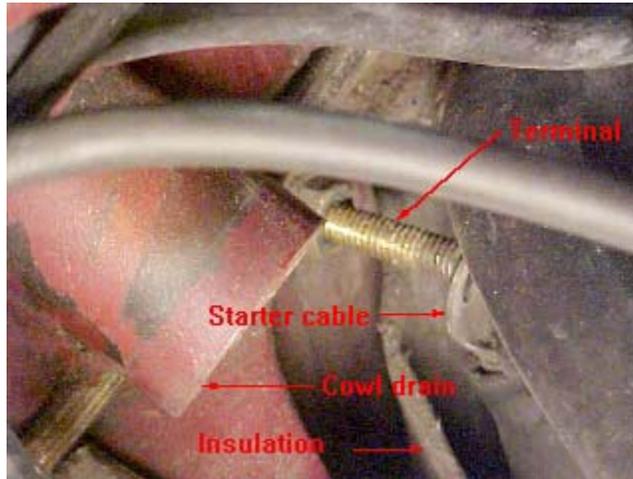
The right post can be reached with removal of only the cowl drain boot. The heater hose can be pushed out of the way as needed. As with the left side, the insulation panel had to be cut away to get the cables off the post. Figure 3 shows the area after the buss has been removed. On this side the rubber boot that is supposed to cover the post is attached to the starter cable. Mine was rotted and broke off while removing the cable from the post. So far, I’ve not found a replacement. I suspect I will have to buy a new starter cable to get

one. Not shown in the photo is the wire going to the starter relay which is on the post as well as the starter cable.

Figure 3 Right terminal post

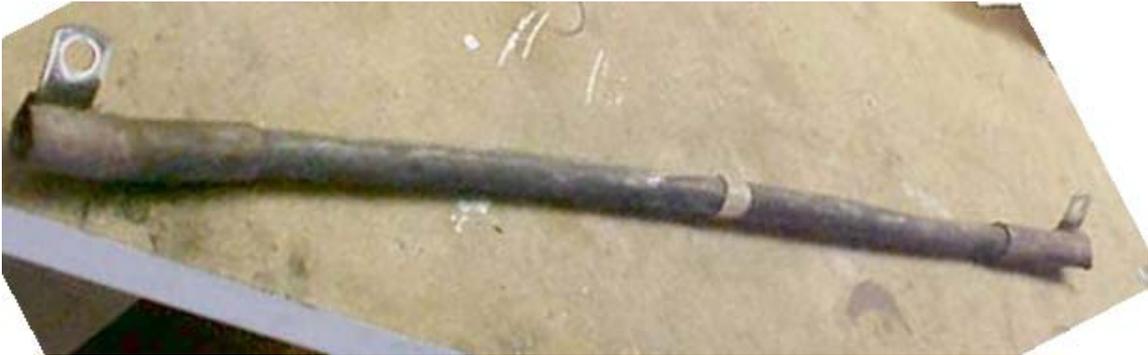
There are actually three nuts on each post. The outer one holds the cables that are tapping power off the post, while the inner one fastens the buss to the post. Once the latter has been removed on both sides the buss can be freed from the posts and maneuvered out of the trough in which it rests against the firewall. It is shown on my workbench in Figure 4, before cleanup.

Figure 4 Front power buss

I scrubbed the entire cable with a spray-on electronics solvent and brushed with a soft wire brush. I was surprised to see that it was really in very good shape, as can be seen in a close-up of one end, Figure 5. I also used a digital volt-ohm meter to measure the resistance from end to end; it was as close to zero as my meter could measure

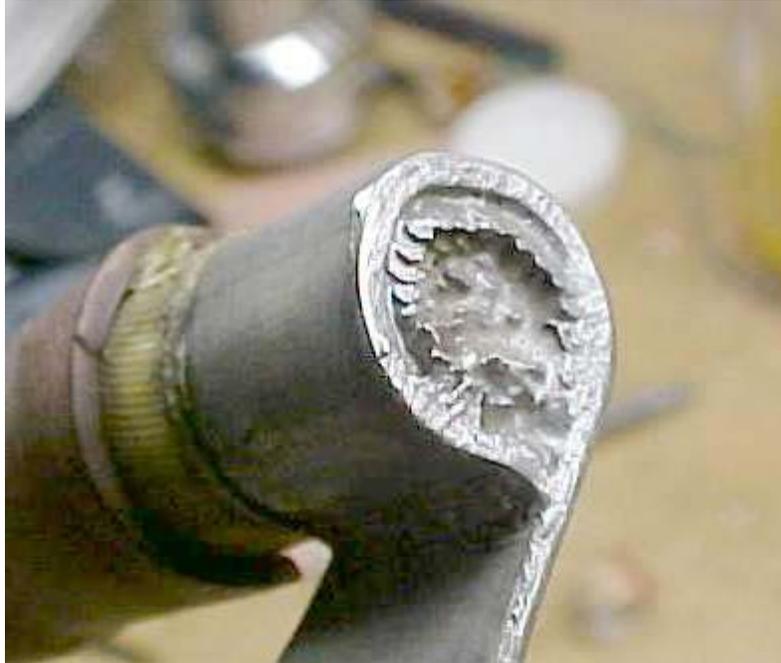
Figure 5 Cable end after cleanup

Before reinstalling the buss I cleaned the terminal posts and fastening nuts with solvent and a wire brush. It is then just a matter of reversing the steps taken in the removal. I offer two important cautions, however. One is to tie threads to the nuts and washers so if you should accidentally drop on it can be recovered. The other is being very careful in tightening the nuts. They obviously must be tight enough to make good electrical contact and not loosen, but you do not want to risk twisting off the post.
