Rebuilding the Jaguar 5.3L V12 Fan Jockey Pulley

Edward F. Sowell
1976 XJ-S
7/13/05

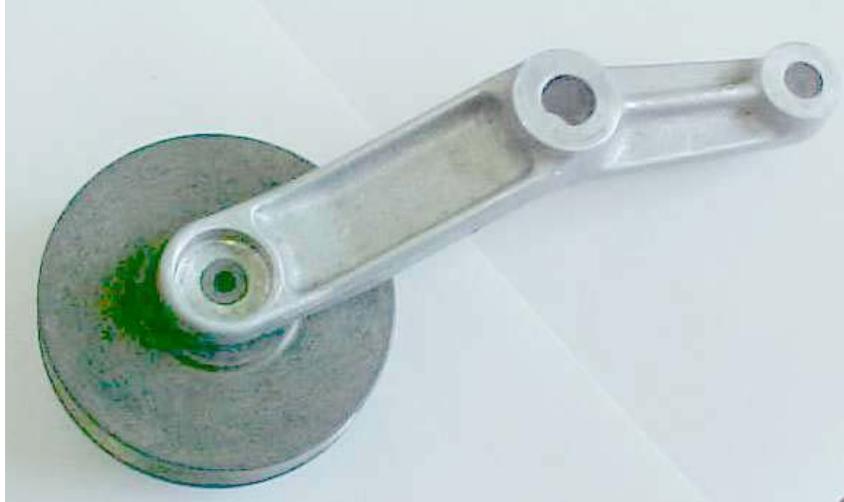
The Jockey pulley is mounted on an arm as shown in Figure 1. The center hole of the arm is for the bolt that screws into the fan bearing housing on which the arm pivots. The hole at the other end is for attachment of the adjustment bolt. The pictured arm is aluminum alloy, but on later cars it is steel or cast iron. Also, in this example the shaft is pressed into the arm and peened. On some early cars the shaft was threaded and held to the arm by a nut.

Figure 1 Fan Jockey pulley and arm.

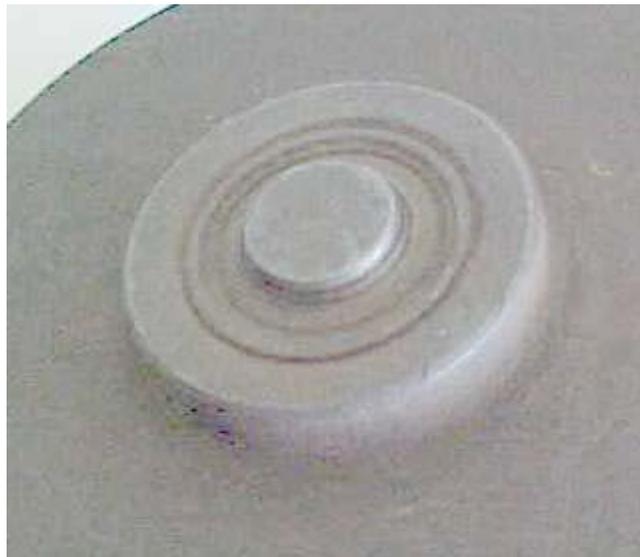
Looking at the other side we see the face of the bearing that is pressed into the pulley, Figure 2. It is the type of bearing normally used in water pumps.

Figure 2 Front of Jockey Pulley.

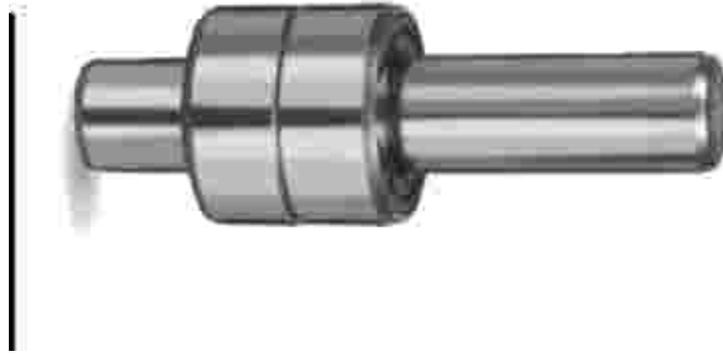
Water pump bearings are unique in that they have two ball bearings and an integral shaft. The inner races for the two bearings are ground into the shaft. Figure 3 shows a typical water pump bearing. The shaft protrudes from both ends, as a water pump has a pulley on one and an impeller on the other. The one used in the fan Jockey needs a shaft only at one end to attach to the arm. Obviously, Jaguar or its supplier got one of the water pump manufacturer to make a special bearing with a single shaft.

Figure 3 Typical water pump bearing.

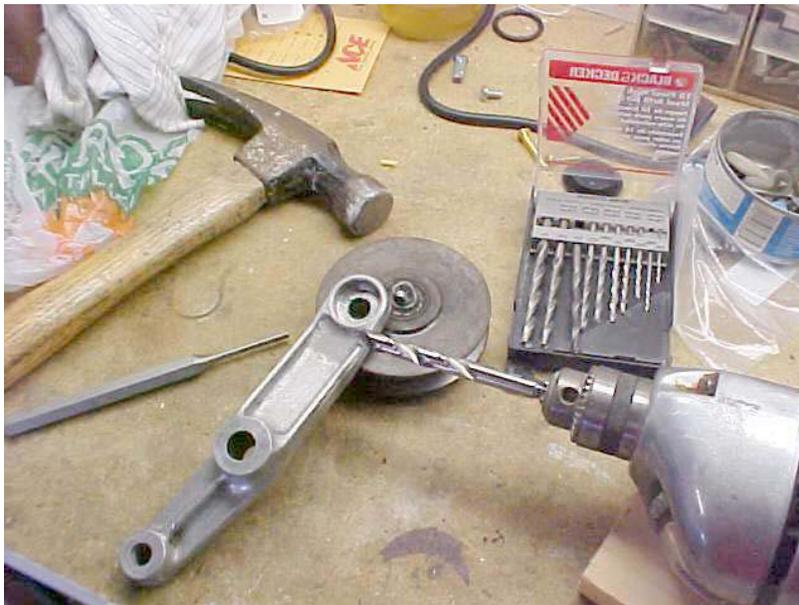
Figure 4 Drilling the shaft out of the arm.

As stated before, the bearing shaft is either threaded and held on by a nut, or pressed into a 3/8" (nominal) diameter hole in the arm and peened. If yours is the pressed and peened type only way to remove it is by drilling it out, Figure 4. The shaft material is soft and drills easily. As can be seen in Figure 1 there is already a pilot hole about 1/8" deep in the shaft end which makes it easy to start. I used a 5/16" diameter bit in a hand drill to drill about 1/4" or so into the end of the shaft.

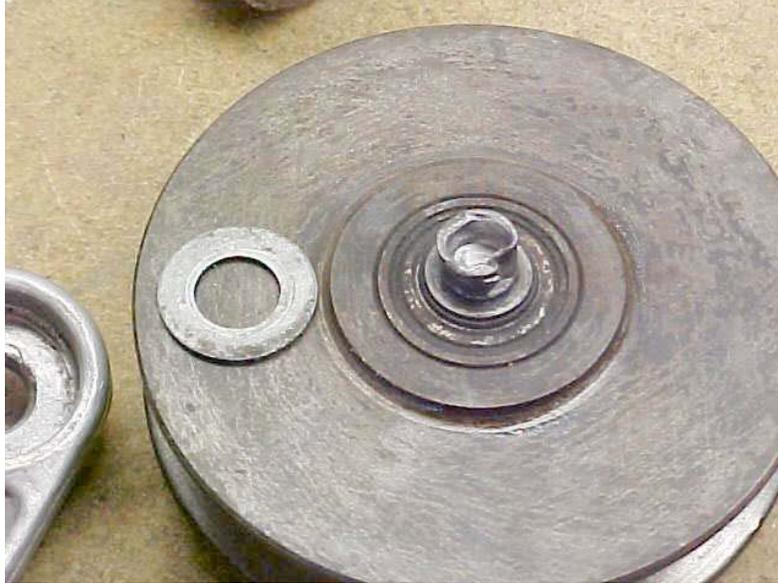
Figure 5 After drilling and removal

After drilling I held the arm in a vise to drive the shaft out. First, I used a punch to strike angled inward blows around the edge, folding the peened rim of the shaft inward, then, a couple axial blows to drive it out, Figure 5. There is a washer to help distribute the load over the pad on the arm. You can see that my drill bit wandered a little off center, breaking through the shaft diameter. It nicked the hole in the arm a bit but this didn't matter much since I intended to use a bolt to attach the new pulley.

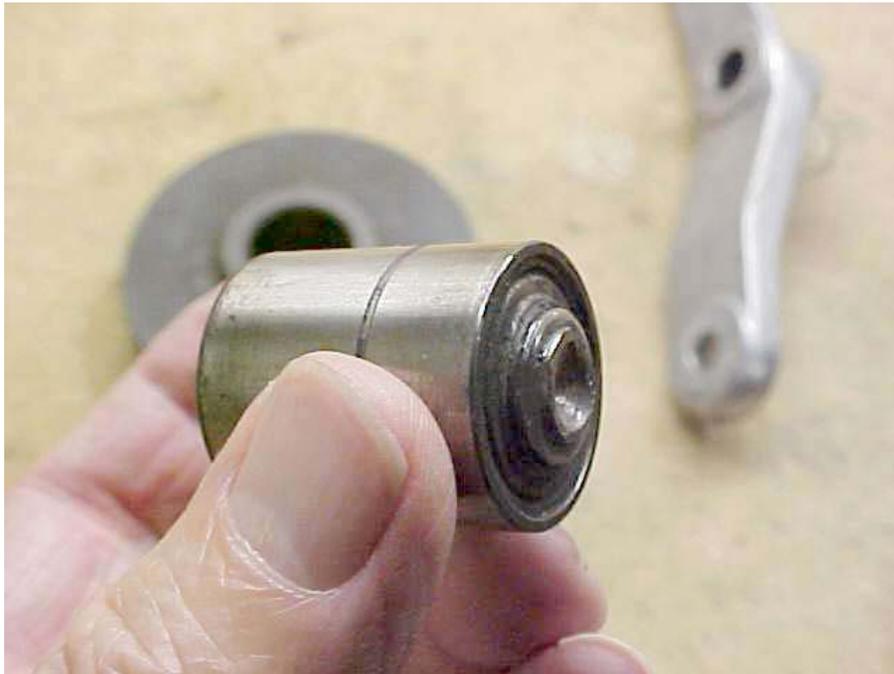
Once the pulley and bearing assembly has been removed from the arm the bearing can be pressed out of the pulley. The machine shop at a local auto parts shop I frequent did it for me without charge. Figure 6 shows the bearing after removal. Apparently, the machinist found it necessary to grind off the shaft a bit to get a good surface to press against.

Figure 6 Bearing after removal.

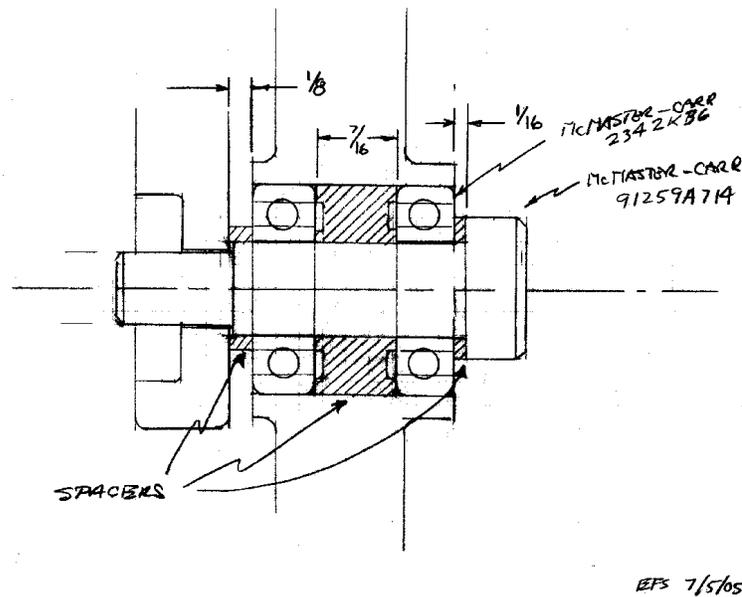
In view of these problems I decided to abandon the water pump bearing idea and go with two normal shielded bearings. My design is shown in Figure 7.

Figure 7 Bearing Replacement Design

The two bearings are pressed into an enlarged pulley bore with a spacer in the middle. The spacer allows both bearings to be clamped through their inner races to the arm with a shoulder bolt. At first thought it might seem that a simpler spacer catching only the inner races would suffice. However, it is also necessary to space the outer races or undesirable axial loads on the bearings will be introduced as they are pressed into the pulley. The relief on the faces of the spacer is to avoid contact with the bearing shields.

Given the thickness of the pulley (1 1/16") and the length of the shoulder, two more spacers are needed. There needs to be a 1/8" spacer between the arm and the pulley back face in order to get the Vee properly aligned with other pulleys on the fan belt. Also, a 1/16" spacer is needed under the head of the bolt to "shorten the shoulder" a bit. The machinist used standard 1/2" steel washers in both places, although McMaster-Car sells (in 100 piece boxes) special shoulder shortening spacers for this purpose. He had to do a bit of machining on the thickness of the outside washer since they are 1/8" thick. The spacer between the two bearings had to be made, as it is nonstandard.

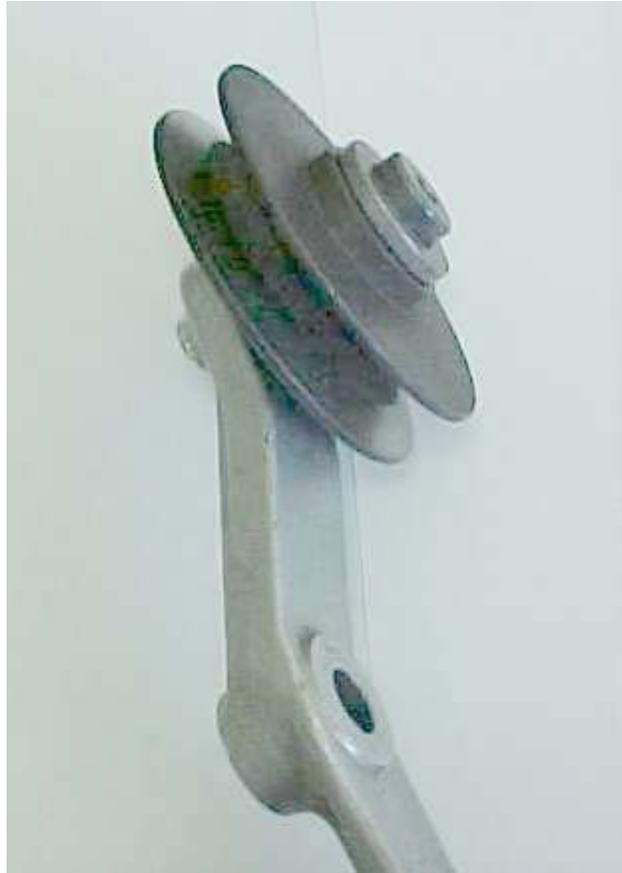
The pulley with newly fitted bearings is shown in Figure 8. It is held to the arm with a 3/8-16 friction nut. Good as new! And it sure is good to have a quiet engine again. Fortunately, it was the jockey rather than the fan bearing!

Figure 8 Rebuilt Jockey Pulley on arm

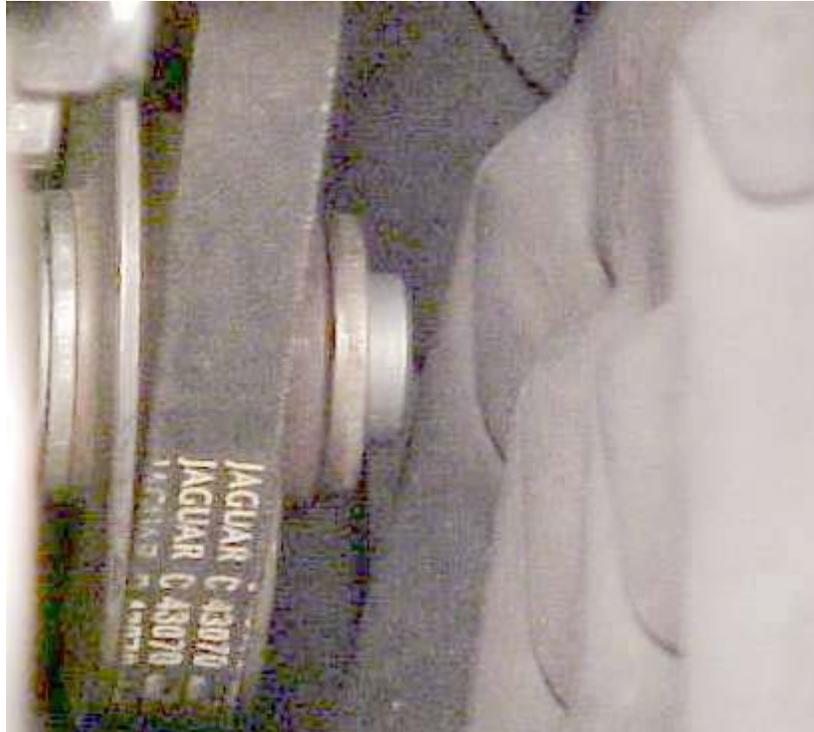
One concern that I had was that the shoulder bolt head clear the fan. I did some measurements as best I could and decided that it would. And it does, but just barely, as can be seen in Figure 9. It looks to be about 1/8". Since the fan and jockey pulley are solidly mounted on the same base I don't expect any relative movement so this should be enough, although I wish it was a little bit more. If I had to do over again I might make some changes to give it another 1/8" clearance, even though it might take a bit more machine work, e.g., a custom made shoulder bolt.

Figure 9 Fan clearance
