FI Hose Damage Due to Crimping or Clamping

Edward F. Sowell

1976 XJ-S

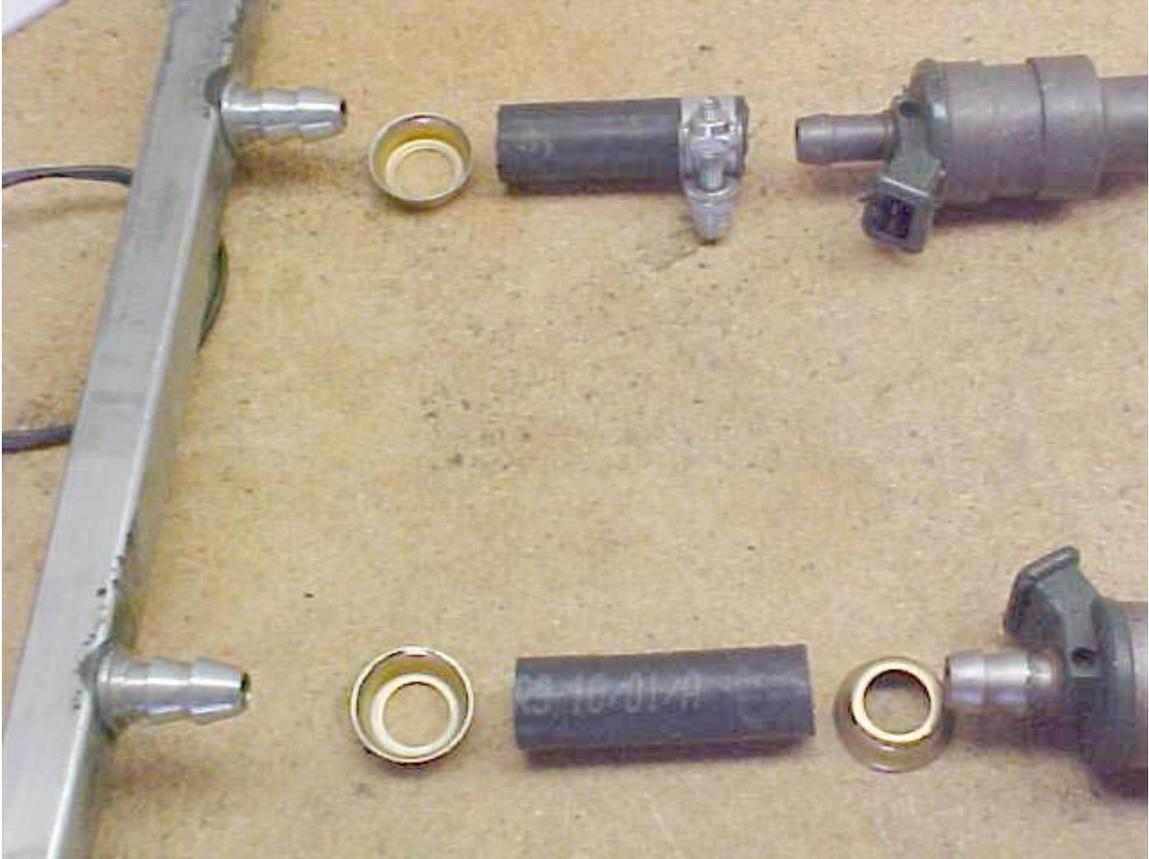
Figure 1 Fuel injector hose joints

The injector hose nipples on the HE rail are completely different than those on the pre-HE rail. Those on the pre-HE are designed for a hose clamp and therefore have a single barb with a flat land for the clamp. In contrast, the HE nipples have two barbs and no flat land for a clamp. This style, sometimes called "push-on" or "Christmas tree," is not designed for clamps, and clamps should not be used. You can see the HE rail nipples in Figure 1. There is a shallow dish-shaped end cap that goes on the nipple first, and then the hose is pushed into place.

Also shown in the photo are two different styles of injector nipples. The one at the top is the older style with flat land behind a single barb, calling for a clamp or a crimped ferrule. Note the style of the clamp, too. The spiral screw type clamps should not be used because they damage the exterior of the hose. The injector at the bottom has the newer Christmas-tree barb like the HE rail. It needs the shallow dished end cap, but no clamp. I also discovered a third nipple style on two of my injectors, made by Bendix. This style, shown in Figure 2, has a single, very sharp barb with a flat land in front of the barb instead of behind it. Originally, these were crimped on with brass ferrules, but I used clamps on them. I'm a bit uneasy about these but they are not leaking.

The use of the dished hose end caps (see Figure 1) at the Christmas tree style nipples is somewhat controversial. Some choose not to use them because they are difficult to get off, making hose replacement more of an ordeal. They argue that these caps are there for aesthetic purposes only, i.e., they are simply "beauty caps." Early in these discussions I argued for the Jaguar caps on the grounds that they tend to compress the hose end around the barb when the hose is pressed on, making a tighter joint and resisting any tendency to pop off when pressurized. Others pointed out that the very similar Parker-Hannifin Push-Lok series hose connectors have plastic caps which are so flimsy they can't possibly offer much in the way of extra strength of the joint. Eventually, I bought into that argument. However, at that time I had no experience with the HE rail. While doing this retrofit project I had an experience that caused me to go back to my original position and fit the end caps at all push-on nipples.

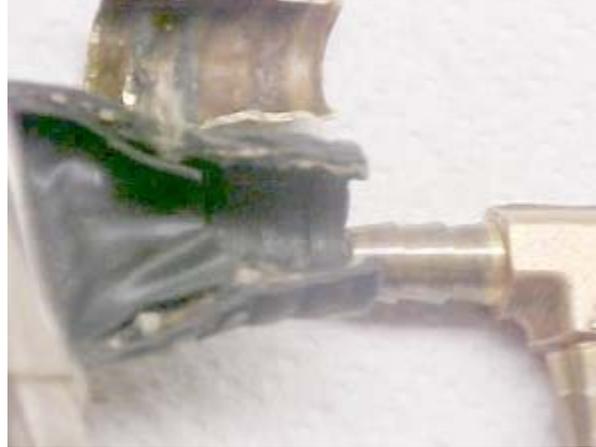
Figure 3 Crimping problem

I drove the car for about a year like this, then began experiencing some problems that caused me to decide to changing the plumbing to eliminate one of the regulators. When I made the change I discovered that my outlet hose assembly was almost totally blocked, taking great effort to blow through the tee joint. What I found is shown in Figure 3, where I have sliced the hose lengthwise to allow viewing of the damage.

What we see here is that the crimping process pressed the hose against the sharp barbs so tight as to cut the inner liner of the hose. The liner then separated from the hose and folded inward, accordion-like, blocking the flow.

It is not difficult to see the factors at play here, not all of which *necessarily* apply to a clamp on a Jaguar FI nipple. For one thing, the air fitting barbs are a bit sharper than the Jaguar fittings. Also, I would judge that the person doing the crimping overdid it a bit. The OD of the fuel hose doesn't match up very well with available ferrule sizes and the one used was oversized, so the guy gave it another go after the first pull on his little hand operated crimper left it still a bit loose. And then perhaps another pull. When he finished the inside of the hose had been cut to pieces, although it looked great on the outside.

In spite of the differences between crimping and clamping, and between brass air fittings and steel FI barbs, there are more similarities. When you use a clamp over the FI nipples it is still the same lined FI hose being pressed tightly against a sharp barb. It is quite clear to me that excessive pressure, which can easily come from over-tightening a clamp, can severely damage the hose.
